# JAS Civil Ltd

Tern Point

## Pavement Inspection Report

We have been requested to undertake a 2nd visual inspection of the road pavement to determine the current condition of the pavement, water courses, and culverts with any recommendation for repair and future programmed works.

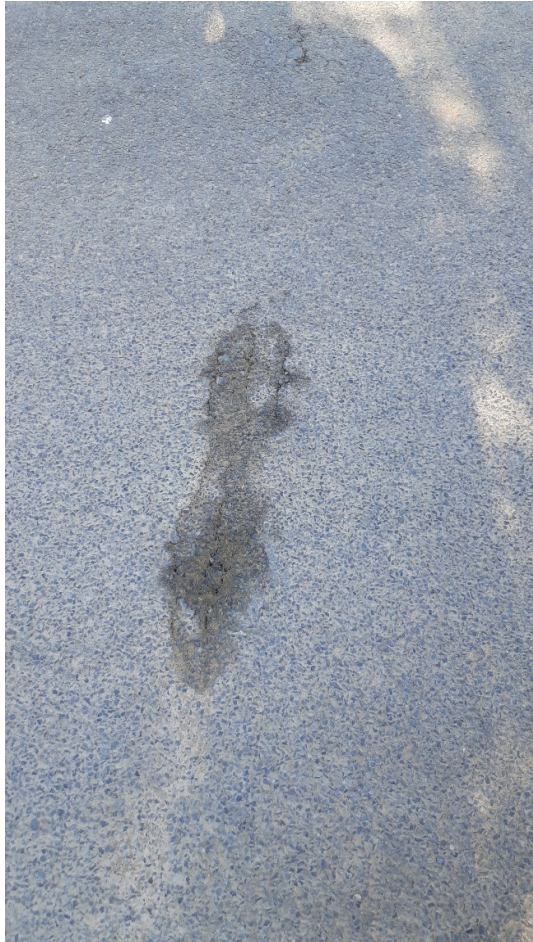
| Photo No | Distance M | Description<br>August 2022 | Description<br>May 2026 | Repairs |
|---|---|---|---|---|
| 1 | 10 | Cracks in seal, covering trench 0.5m long, moisture showing<br>Need to monitor for possible failure. | Cracks are located over a trench, assuming for gate sensor. Appears more cracks but no potholes | Monitor |

Photo 1 – There appears to be more cracks in this area. While the road has not potholed it has the potential to enlarge and cause pot holing. This should be monitored over time and repaired if worsens.

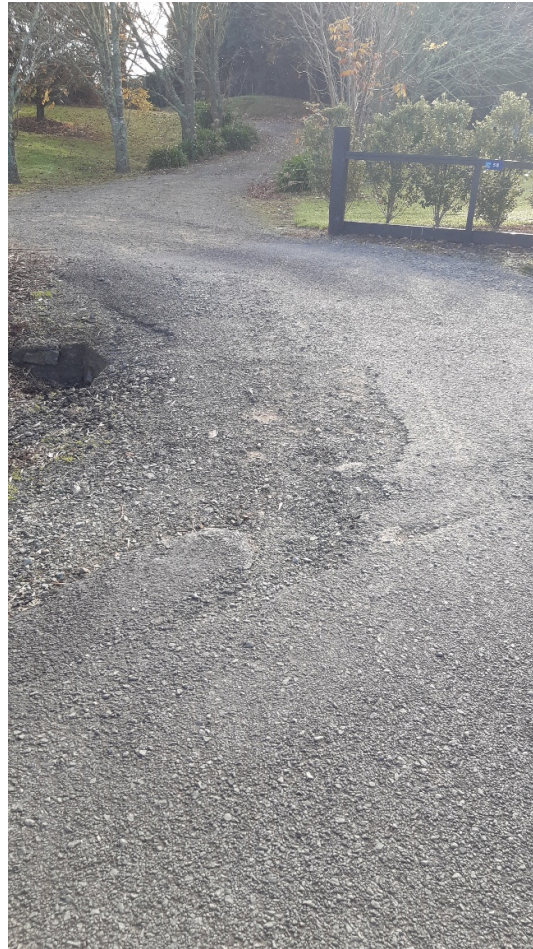
Photo 2

| Photo No | Distance M | Description<br>August 2022 | Description<br>May 2026 | Repairs |
|---|---|---|---|---|
| 2 | | | Lot 58 – seal breaking up LHS of entrance | |

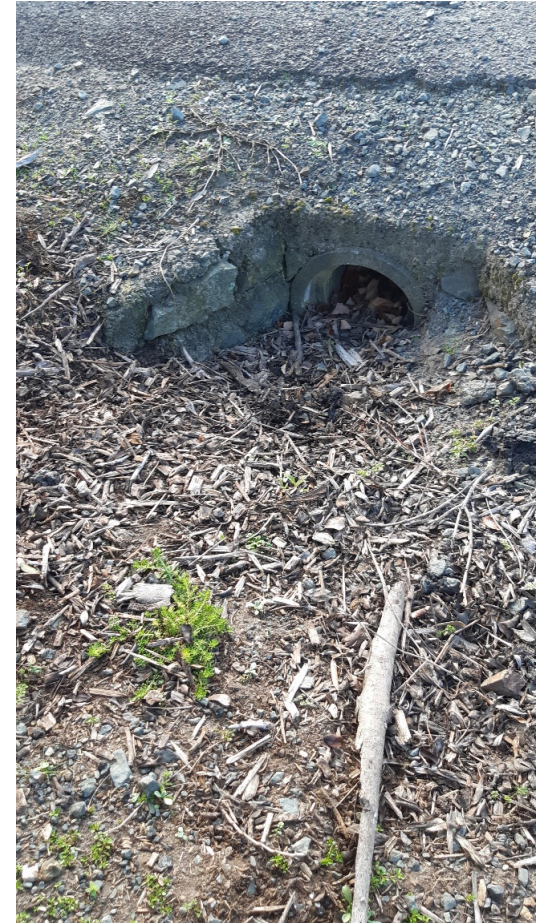
Photo 3

| Photo No | Distance M | Description<br>August 2022 | Description<br>May 2026 | Repairs |
|---|---|---|---|---|
| 3 | | | Lot 58 -culvert partially blocked with leaves.<br>Probably not worth cleaning as outlet is higher than ground level. Will just fill up again | Nil |

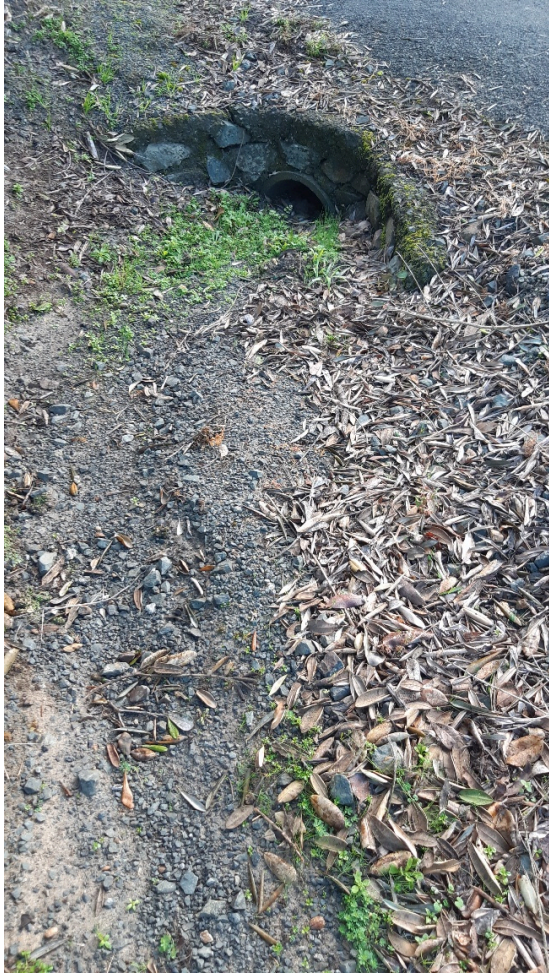
Photo 4

| 4 | | | Lot 70 – Culvert half blocked | Flush out |

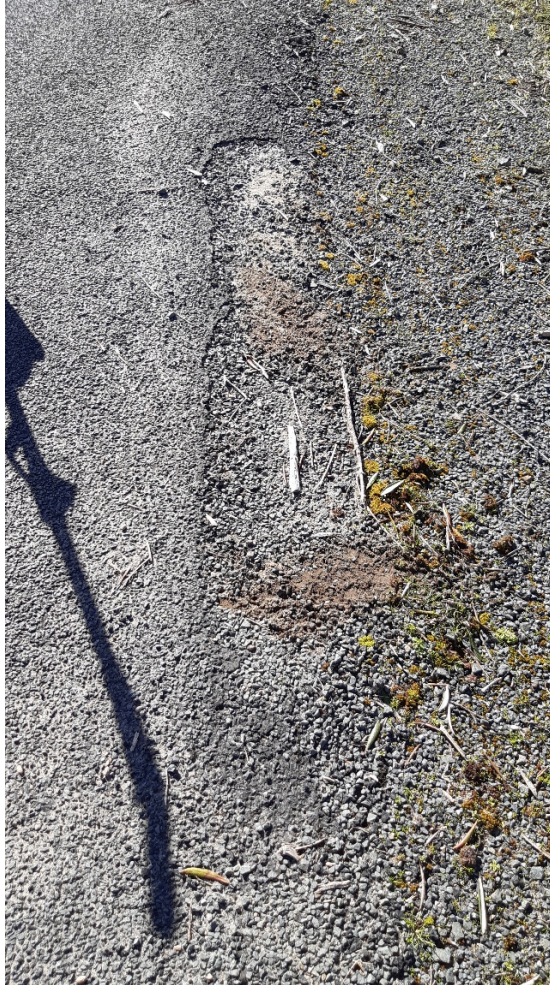
Photo 5

| 5 | 720 | Re-seal has not adhered, original seal still in tacked | No change | Nil |

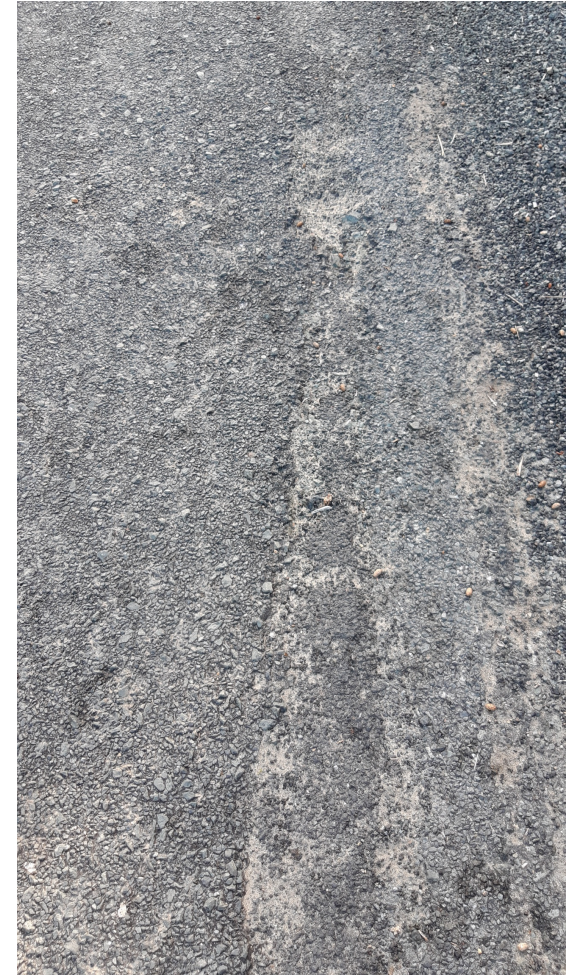
Photo 6

| 6 | 748 | | Re-seal has not adhered, original still in tacked. | Nil |

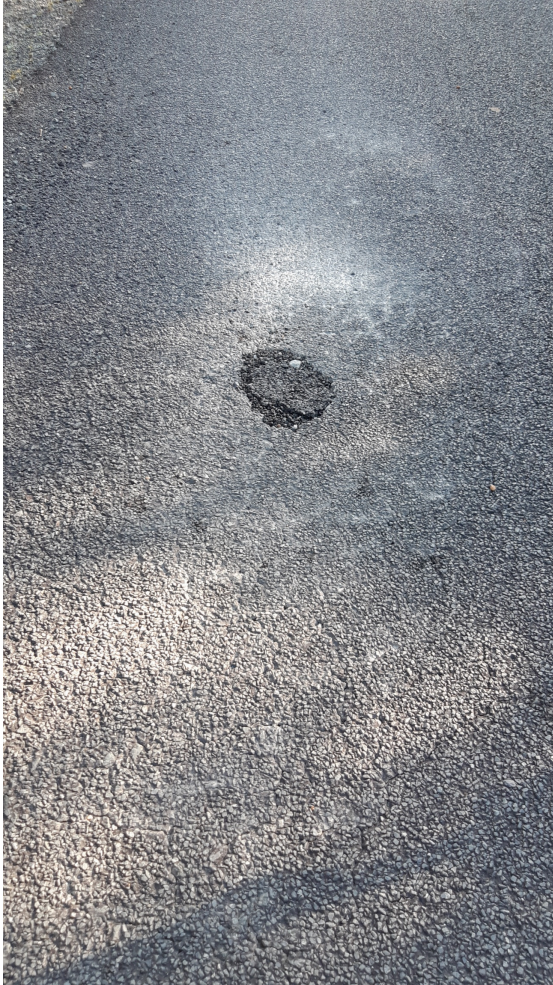
Photo 7

| 7 & 8 | 883 | Just before entrance 96 | Pavement failure, just before entrance 96 (4 x2) | Dig out and asphalt |

Photo 7,8 & 9 – These are the only areas of real concern. The pavement is failing and potholes will soon appear. We recommend these areas be dug out approximately 250 – 300mm deep, re-metalled and compacted with GAP40 and sealed with 25mm asphalt.

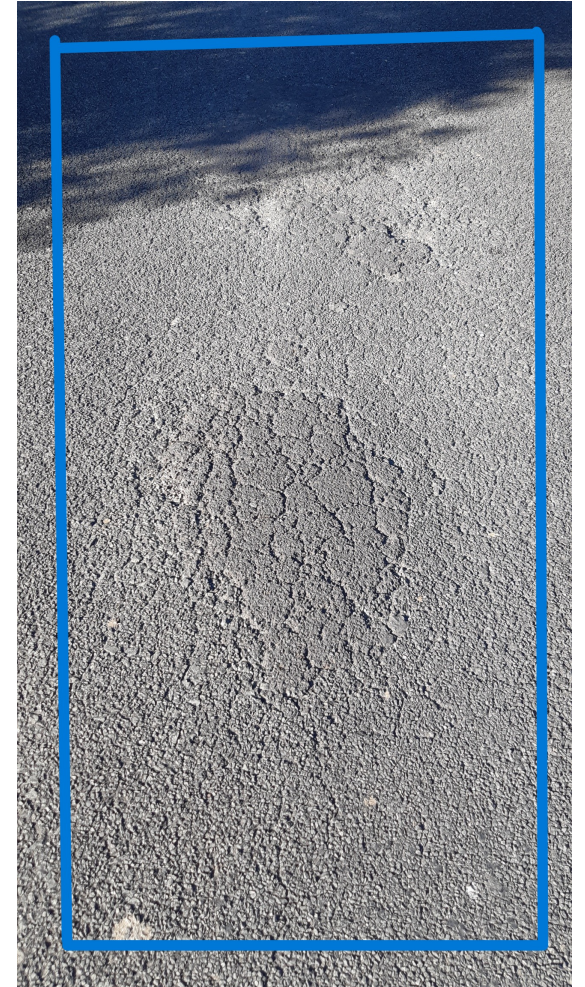
Photo 9

| 9 | | | Pavement failure outside loading ramp. Some repairs undertaken | Dig out and asphalt |

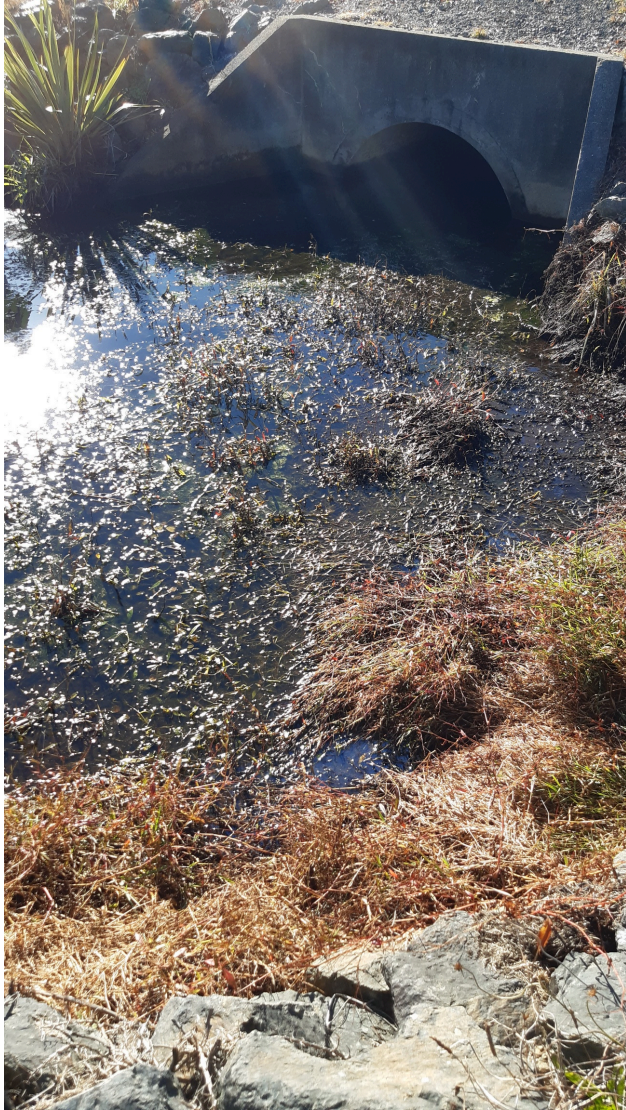
Photo 10

| 10 - 11 | 1061 | Culvert crossing – both inlet and outlet rock work show no sign of movement or colipase | Inlet and outlet have a lot of weed growing.<br>It would be advisable to clean out. | Clean out weed |

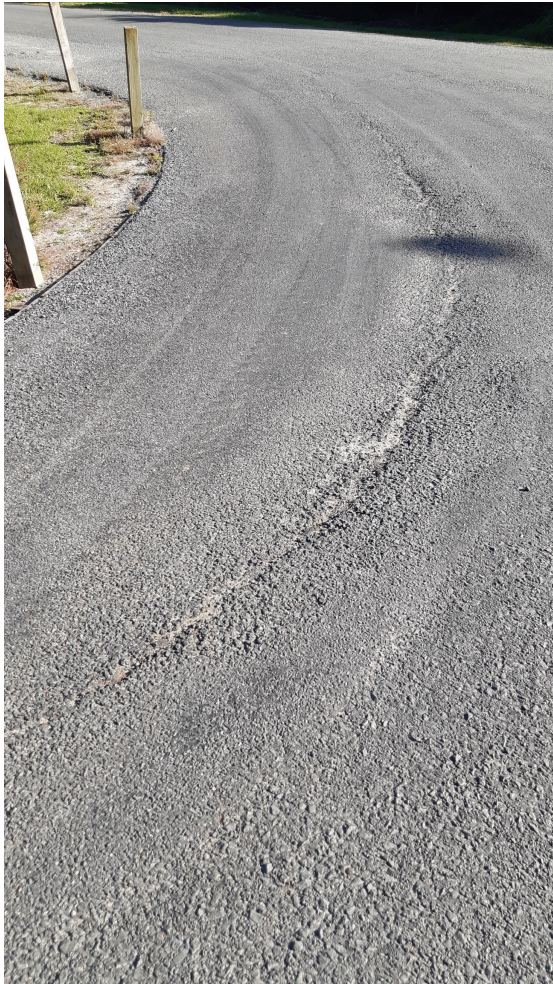
Photo 12

| 12 | | | Intersection into Quail Lane – The widening on LHS deteriorating caused by traffic turning into Quail Lane | Asphalt |

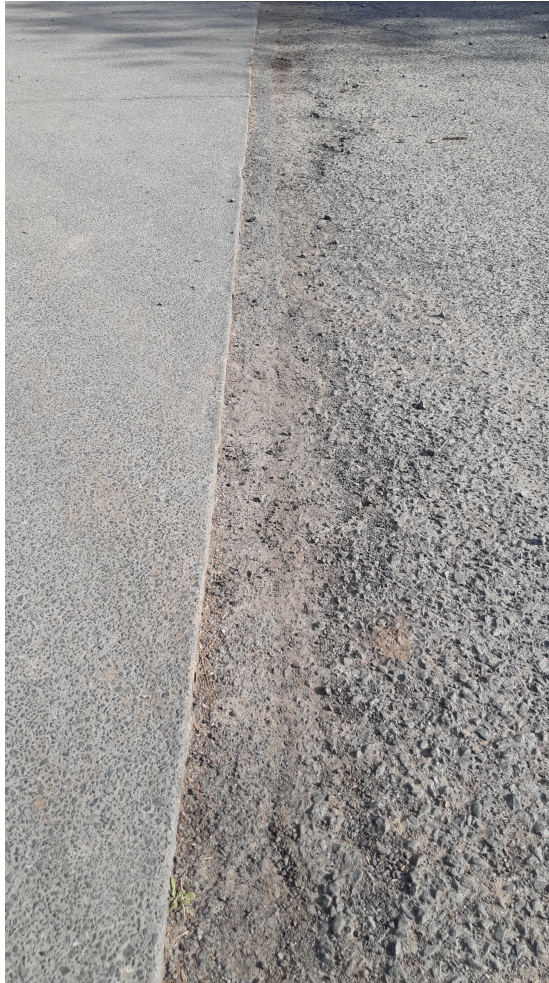
Photo 13

| 13 | End Quail lane | | Todd, Brown entrance – Construction work under progress. Seal ripped on entrance only, no potholes. | Suggest asphalt entrance/seal connection on completion. |

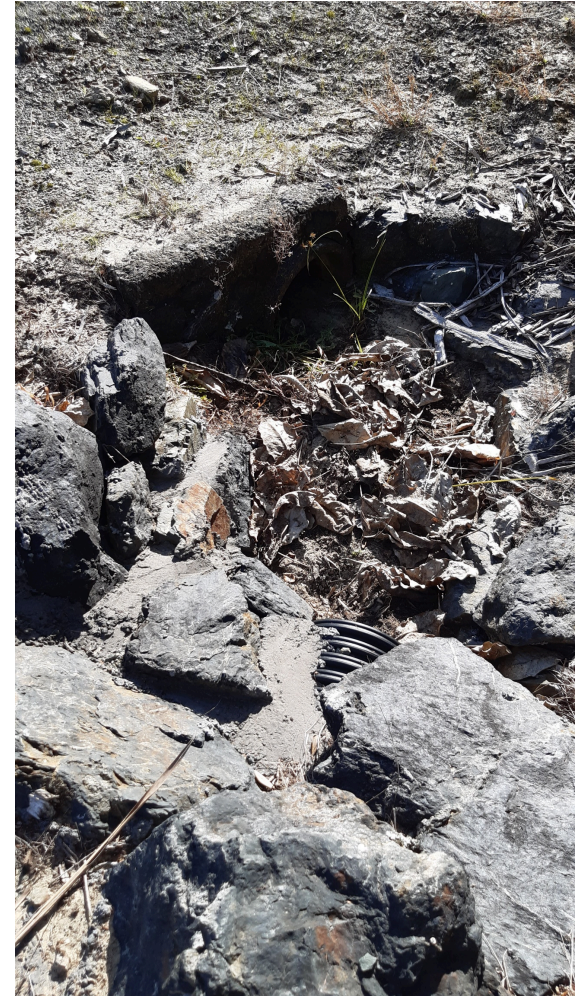
Photo 14

| 14-15 | | Culvert inlet, blocking with sand RHS | Dune lane intersection RHS. Some sand in base of culvert outlet/inlet needs constant clearing | Constant clearing |

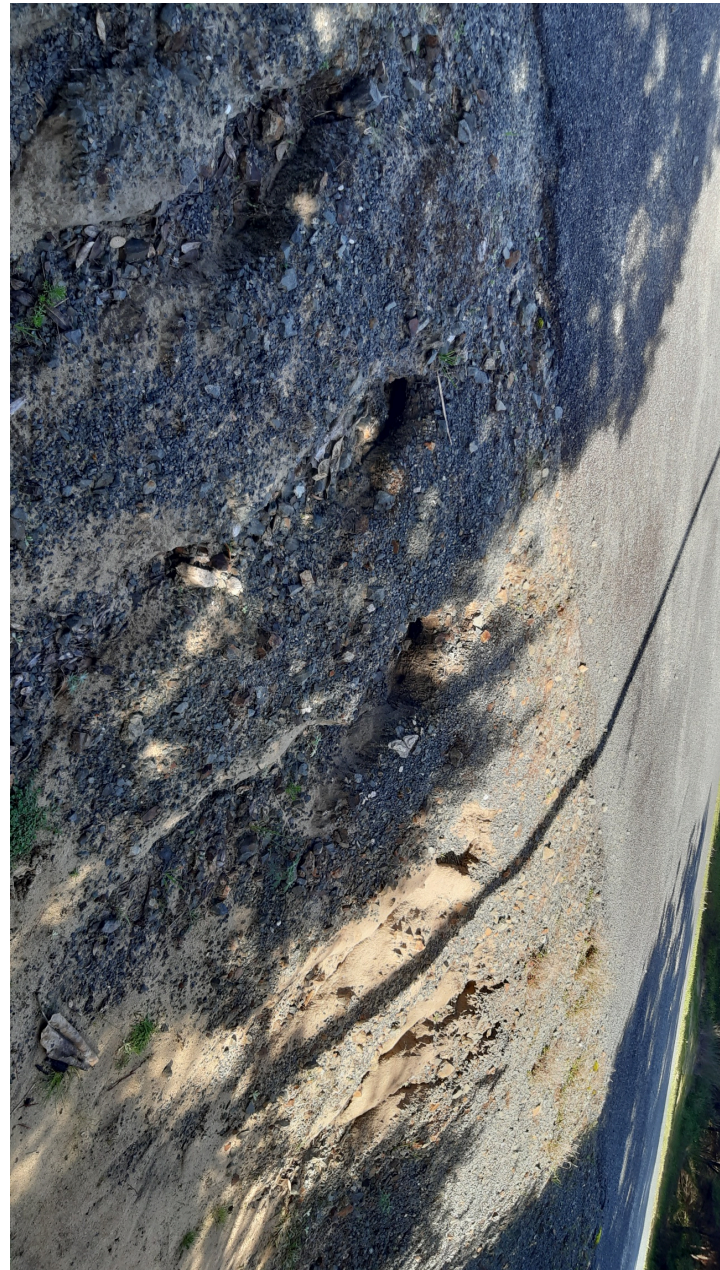
Photo 16

| 16-17 | | Culvert as above LHS | Dune Lane intersection LHS. Bank scouring and filling waterway. | Rock protection required |

Photo 15, 16 – The LHS swale drain at entrance to Dune Lane is scouring out. We suggest some rock work along the bank to prevent further erosion.

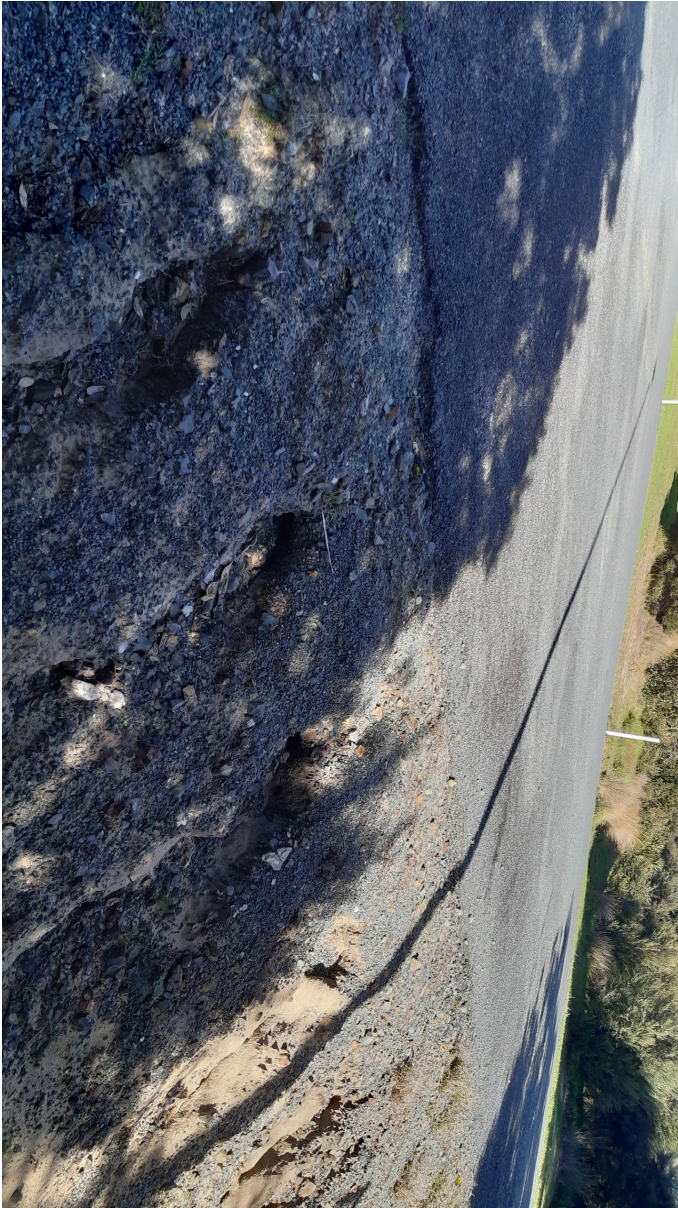
Photo 18

| 18 | 80 to top | | Channel filled with sand | Clean out |
